MAP 12b: Eelgrass Presence Galiano Island Local Trust Area - North

Produced by: Galiano Conservancy Assoc.
Map Date: December 12th, 2013
Orthophoto Date: 2011
Scale: 1 : 15,000
Map Projection: UTM Zone 10N, NAD83

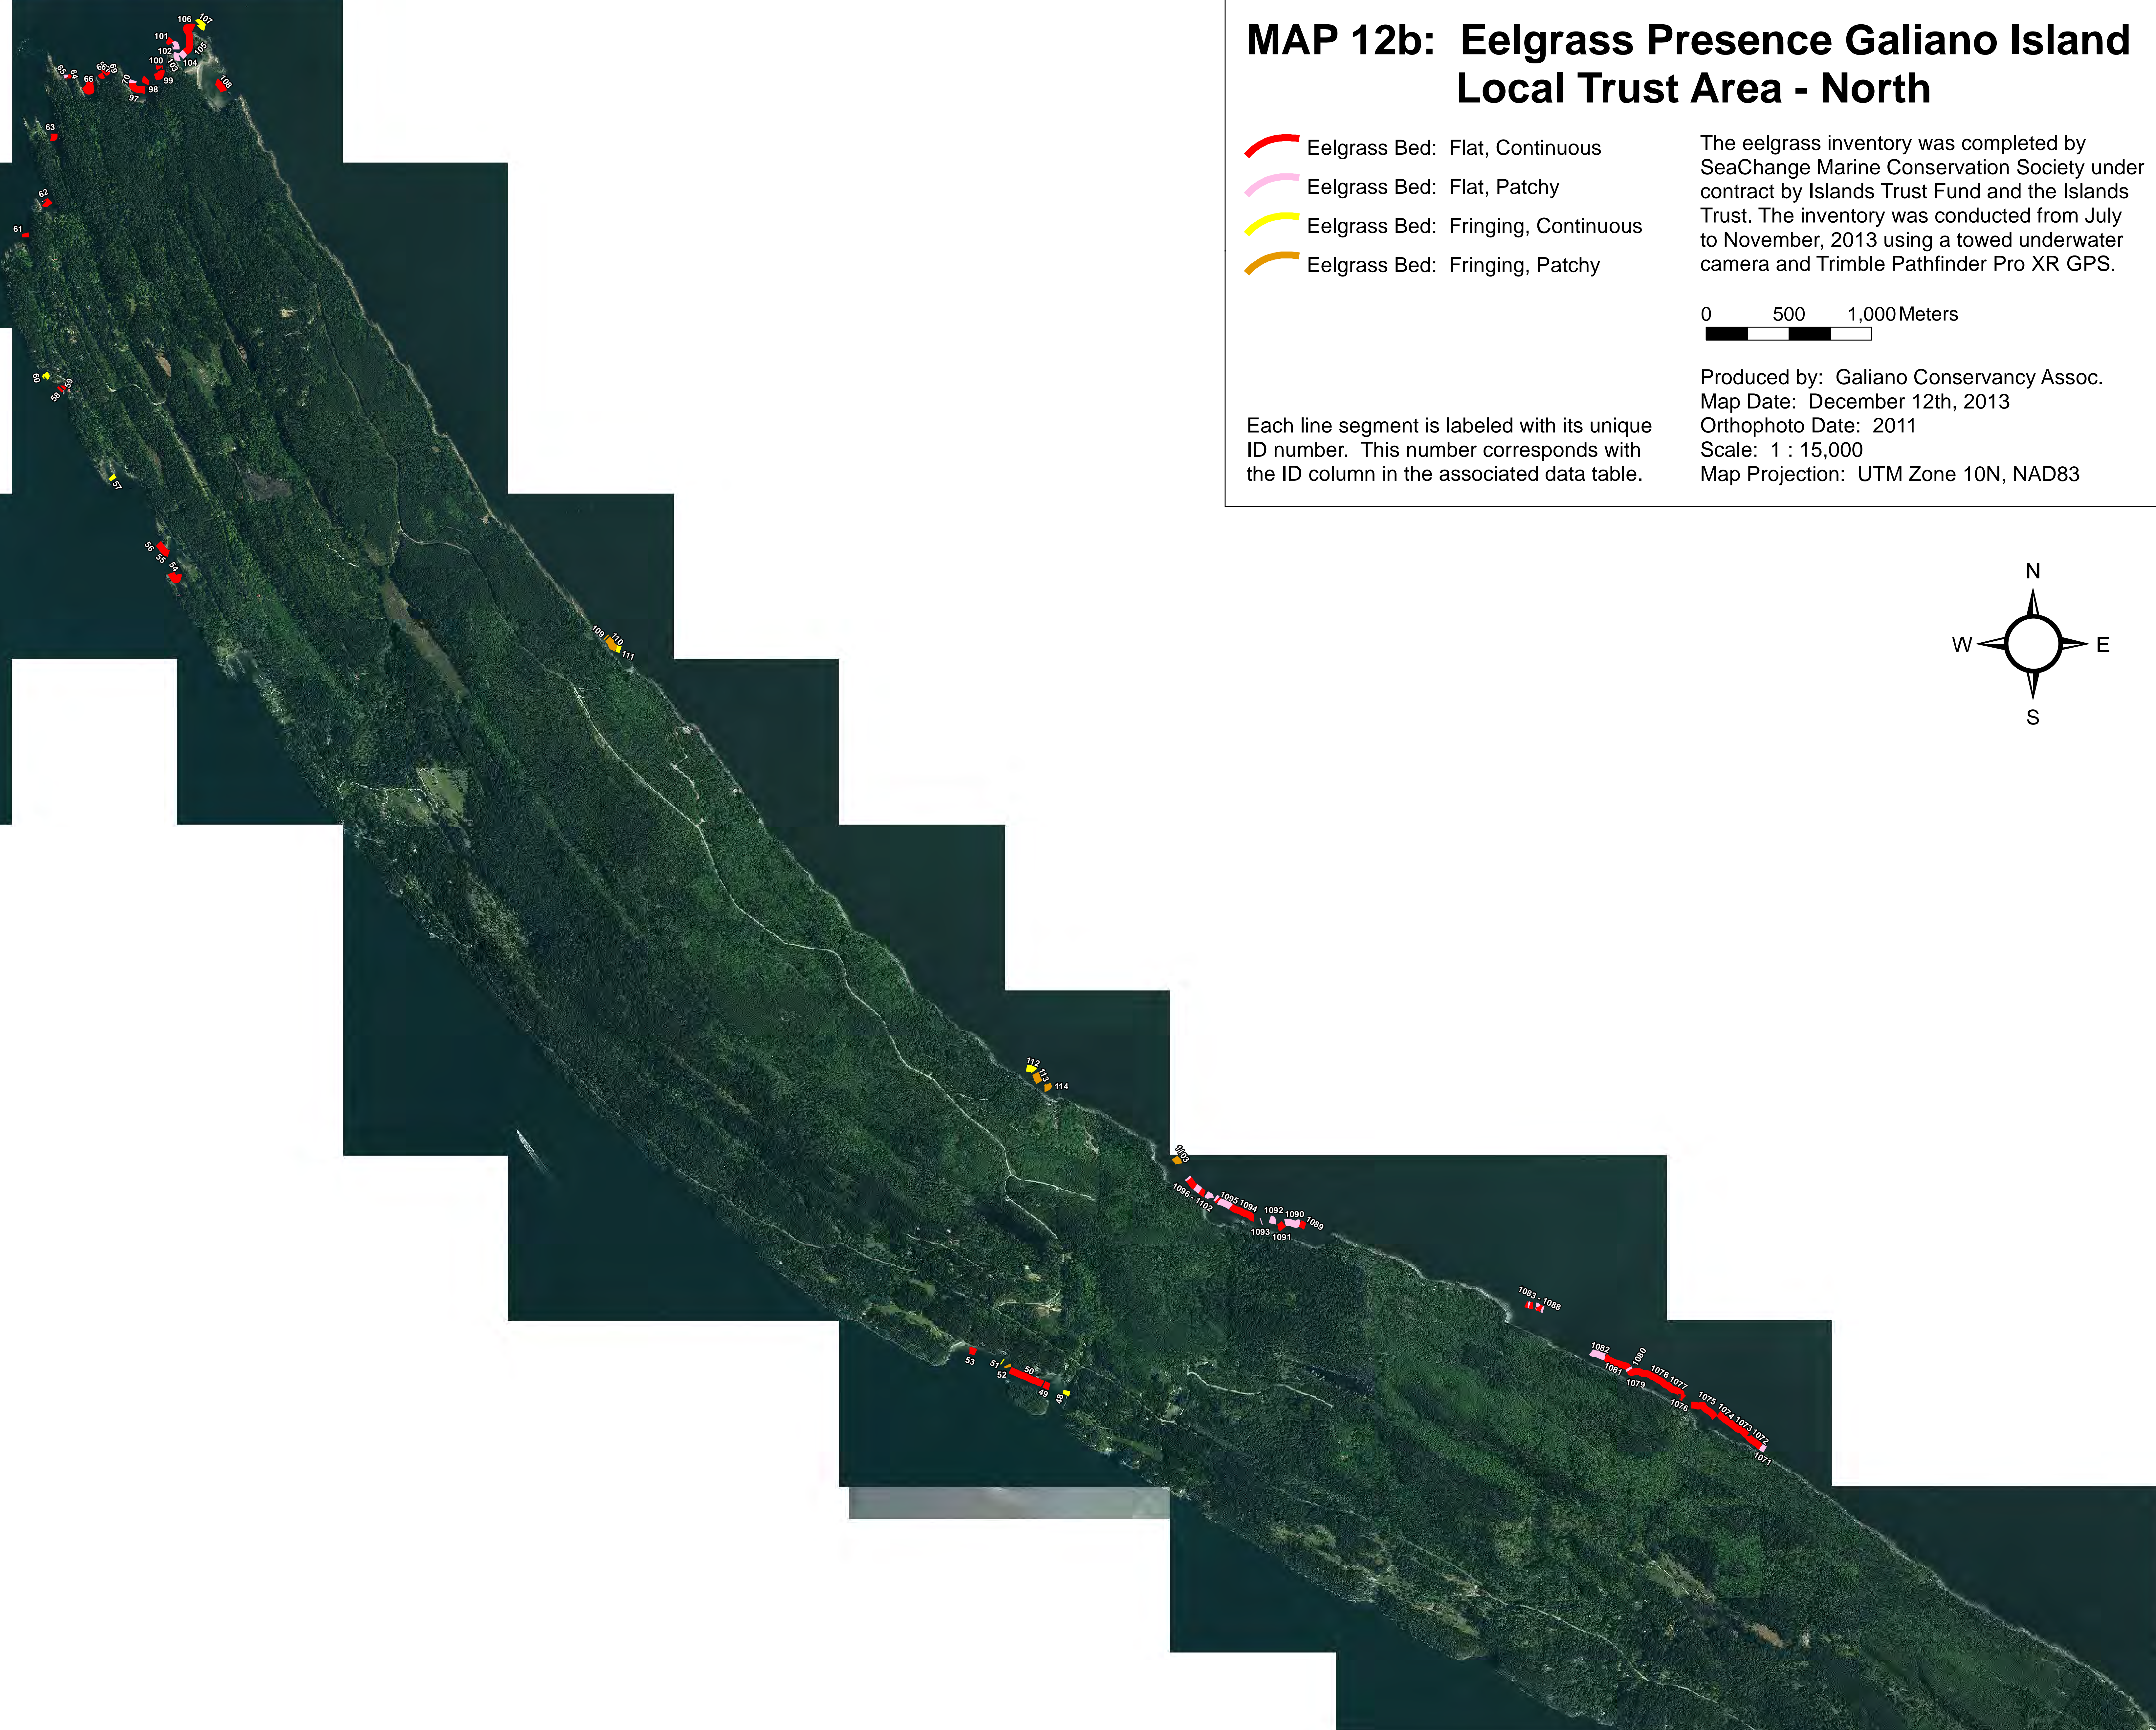
The eelgrass inventory was completed by SeaChange Marine Conservation Society under contract by Islands Trust Fund and the Islands Trust. The inventory was conducted from July to November, 2013 using a towed underwater camera and Trimble Pathfinder Pro XR GPS.

Each line segment is labeled with its unique ID number. This number corresponds with the ID column in the associated data table.
